> Re: National Pollutant Discharge Elimination Stormwater Inspection Coal-Fired Steam Power Plant and Marine Cargo Handling Facility MSGP Tracking Number PRR053093

# UNITED STATES ENVIRONMENTAL PROTECTION AGENCY, REGION 2

National Pollutant Discharge Elimination Stormwater Inspection Coal-Fired Steam Power Plant and Marine Cargo Handling Facility MSGP Tracking Number PRR053093

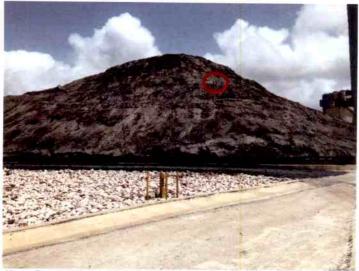
#### Picture 3

<u>Finding</u>: During the walkthrough, the EPA Inspector did not observe any spraying nozzles in operation to control dust. Mr. González indicated that three (3) of the nine (9) nozzles were undergoing repairs or replacement. **Picture 3** and **Picture 4** are examples that depict this observation.

Note: Southeast view of the CCR storage pile.

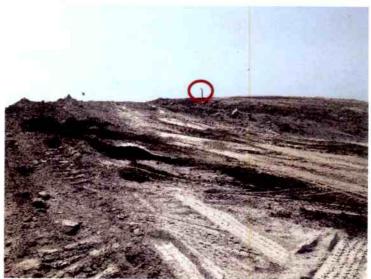
Picture 4

Note: Top of CCR storage pile looking towards the east side of the Facility.

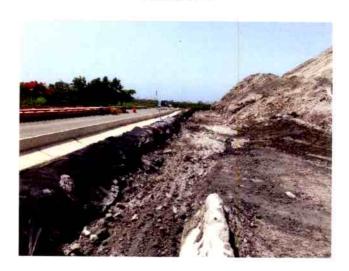
### Picture 6

<u>Finding</u>: The super silt fence placed over the gabion structure along the east side of the Agremax pile was in disrepair. **Picture 6** depicts this observation.

Photo: Geotextile material placed over the gabion structure.

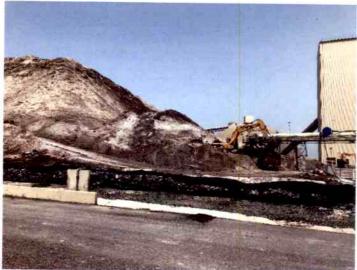
AES added a second roadway at the pile that runs westbound along the north side of the pile. The entryway is on the east side, and shown on **Picture 9**.

Note: Transportation of CCR to the top of the pile was taken place during the walkthrough of the storage pile.

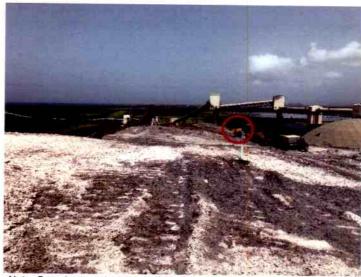
Picture 10

A water-mounted tank truck was observed spraying water in areas where the CCR was being deposited at the top of the storage pile. **Picture 10** depicts the truck, a spraying nozzle (not in service), and loose and dry CCR at the top of the storage pile. **Picture 11** depicts a spraying nozzle (not in service); and dry, loose and small CCR particles at the top of the storage pile. **Picture 12** depicts the added roadway on the northwest side, a slope showing dry conditions, the coal pile and the dome.

Note: Spraying nozzle was not spraying water.

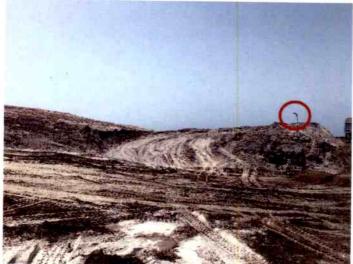
Note: Spraying nozzle was not spraying water.

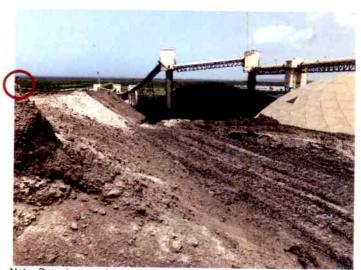
Picture 12

Note: Spraying nozzle was not spraying water.

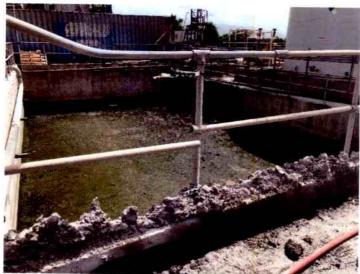
Picture 13 depicts the secondary containment.

<u>Finding</u>: The diesel tank secondary containment lack good housekeeping practices, had a light-green colored water accumulation, and Agremax was stockpiled along the top of the concrete berm.

Note: Although not shown on this picture, the EPA Inspector observed two individuals working with what appeared to be a portable pump. See the red-colored hose laying on the ground.

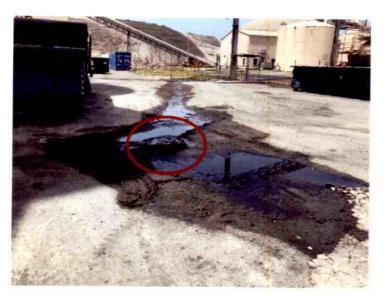
<u>Findings</u>: The inlet was surrounded with significant accumulation of sediment, which resulted from an excavation that was not provided with erosion control. Also, sediment and dust accumulation were observed in the roadway towards the Agremax pile **Picture 14** depicts the observation about the inlet. **Picture 15** depicts the observation about sediment and dust accumulation.

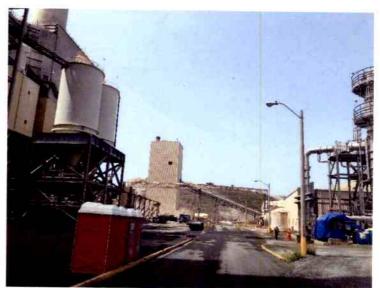
Note: The entrance to the cooling tower is also depicted in this picture.

Findings: The dirt road entrance to the cooling tower had exposed soil and lacked soil stabilization in several areas. The EPA Inspector did not see the sweeper-mounted vehicle in operation during the walkthrough of the Facility.
